**Flood Control Project Maintenance
Levee Inspections**

Maintenance Issue Types Only, Levee Inspection Report By Mile - Spring 2018

Reclamation District No. 0817 Carlin

Waterway	Bank	Unit Miles	Inspection Start/End	Inspector
Unit No. 01 South Dry Creek	Left	3.81	04/18/2018 04/18/2018	Sterling York

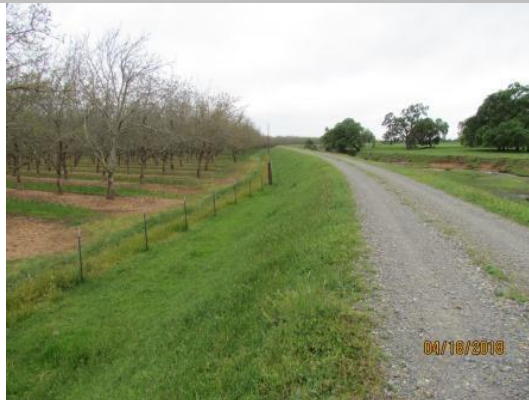
Photo 1 of 1 : SP_2018_RD0817_12_26_20180501_00018.jpg

LM Start	0.00	Rating **	A	Issue No.	26
LM End	3.81	Issue Type +	Ma	Location *	LS
Category	Earthen Levee			GPS Latitude/Longitude	
				Start	End
Item	Vegetation			38.984668 °	39.019765 °
				-121.506110 °	-121.454085 °
DWR ID	DWR_RD0817_01_s_2018_26				
Comment Code					
V1 : Control annual grass and weeds on the levee slopes and easements.					
Inspector Comment					
Annual vegetation is maintained, Spring 2018.

View looking downstream landside of the maintained annual vegetation, Spring 2018.

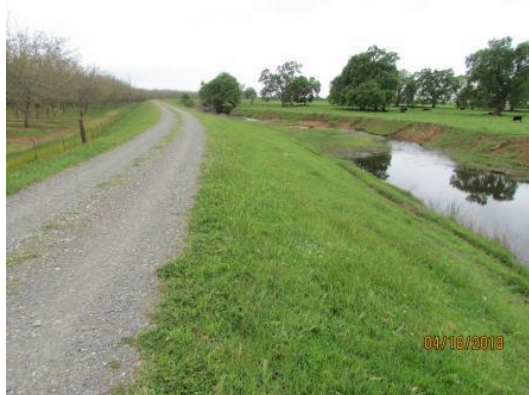
Photo 1 of 1 : SP_2018_RD0817_12_27_20180501_00019.jpg

LM Start	0.00	Rating **	A	Issue No.	27
LM End	3.81	Issue Type +	Ma	Location *	WS
Category	Earthen Levee			GPS Latitude/Longitude	
				Start	End
Item	Vegetation			38.984668 °	39.019765 °
				-121.506110 °	-121.454085 °
DWR ID	DWR_RD0817_01_s_2018_27				
Comment Code					
V1 : Control annual grass and weeds on the levee slopes and easements.					
Inspector Comment					
Annual vegetation is maintained, Spring 2018.

View looking downstream waterside of the maintained annual vegetation, Spring 2018.

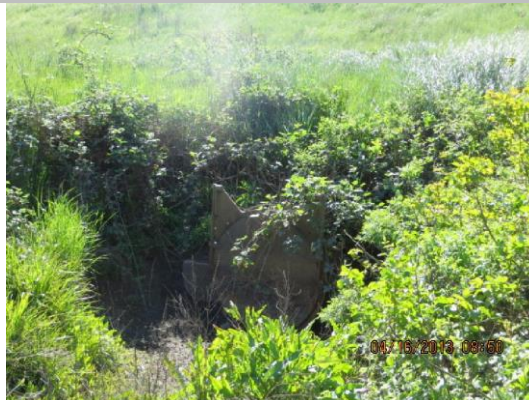
Photo 1 of 3 : UCIP_SP_2018_42685_19865.jpg

LM Start	0.29	Rating **	M	Issue No.	28
LM End	0.29	Issue Type +	Ma	Location *	
Category	Supplemental			GPS Latitude/Longitude	
				Start	End
Item	DWR UCIP LMA Responsibility			38.987813 °	38.987813 °
				-121.502963 °	-121.502963 °
DWR ID					
Comment Code					
Inspector Comment					
FS_ID:42685 DS_ID:18985 EP_NO: N/A Repair Type: Non-Urgent Crossing Status: Found UCIP Comments: Dense vegetation on waterward and landward slopes limit visual inspection of potential leaks along pipe alignment. Recommend having owner clear vegetation along slopes. FIELD_STRUCT_DESC: 48-inch corrugated metal gravity drainage pipe through the levee, 23.3 feet below the crown. Flap gate on the waterside (WS) end. [Additional Reference(s): DWR Levee Log, 2005. USACE Sacramento O&M Manual 146, November 1962, (HLM 0.28)]. FS Date: 4/16/2013

WS- pipe, flap gate in dense vegetation on berm

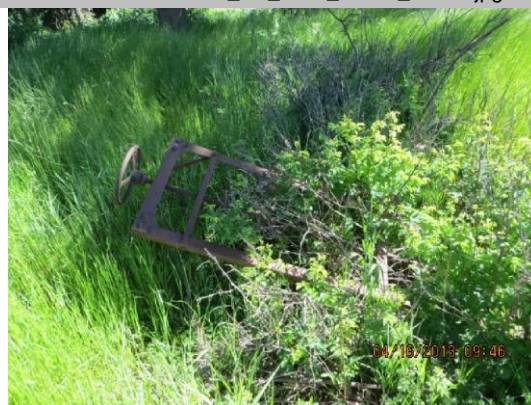
Photo 2 of 3 : UCIP_SP_2018_41153_19881.jpg

FS_ID:41153
DS_ID:18987
EP_NO: N/A
Repair Type: Non-Urgent
Crossing Status: Found
UCIP Comments: Damaged slide gate on WS of the levee. Need to contact owner to determine status of crossing. If crossing is no longer in use owner will need to contact CVFPB to comply with Title 23. Dense vegetation on waterward and landward slopes limit visual inspection of potential leaks along pipe alignment. Recommend having owner clear vegetation along slopes.
FIELD_STRUCT_DESC: *ABANDONED* 18-inch corrugated metal gravity drainage pipe through the levee, 14.9 feet below the crown.
Slide gate on the waterside (WS) end. [Additional Reference(s): DWR Levee Log, 2005. USACE Sacramento O&M Manual 146, November 1962, (HLM 1.34)].
FS Date: 4/16/2013

WS- closer look at damaged slide gate on WS

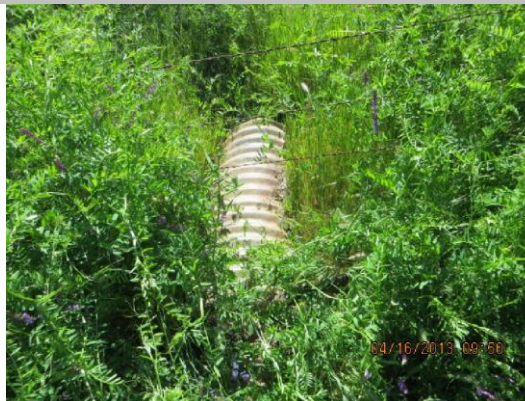
Photo 3 of 3 : UCIP_SP_2018_41153_19884.jpg

Comment Code						
Inspector Comment						
FS_ID:41153						
DS_ID:18987						
EP_NO: N/A						
Repair Type: Non-Urgent						
Crossing Status: Found						
UCIP Comments: Damaged slide gate on WS of the levee. Need to contact owner to determine status of crossing. If crossing is no longer in use owner will need to contact CVFPB to comply with Title 23. Dense vegetation on waterward and landward slopes limit visual inspection of potential leaks along pipe alignment. Recommend having owner clear vegetation along slopes.						
FIELD_STRUCT_DESC: *ABANDONED* 18-inch corrugated metal gravity drainage pipe through the levee, 14.9 feet below the crown. Slide gate on the waterside (WS) end. [Additional Reference(s): DWR Levee Log, 2005. USACE Sacramento O&M Manual 146, November 1962, (HLM 1.34)].						
FS Date: 4/16/2013

LS- CMP on toe of the levee.

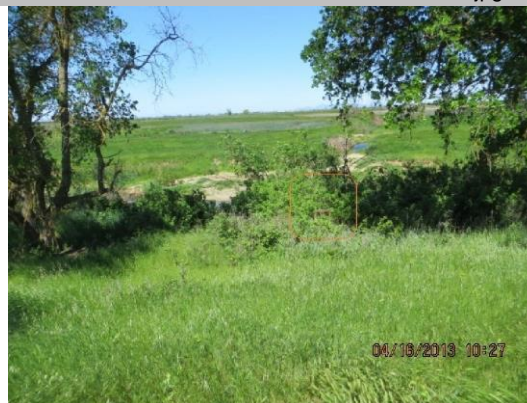
Photo 1 of 3 : UCIP_SP_2018_41157_19892.jpg

WS- overview of WS berm

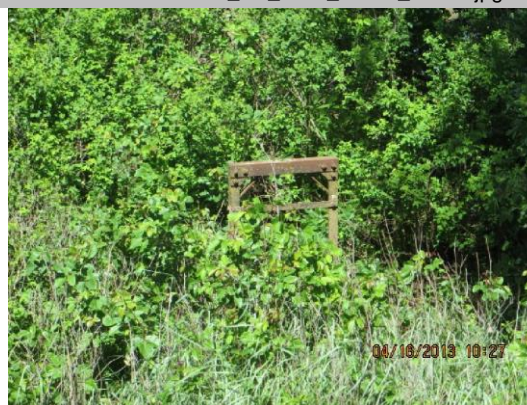
Photo 2 of 3 : UCIP_SP_2018_41157_19891.jpg

FS_ID:41157
DS_ID:18988
EP_NO: N/A
Repair Type: Non-Urgent
Crossing Status: Found
UCIP Comments: A buried slide gate on WS of the levee. Need to contact owner to determine status of crossing. If crossing is no longer in use owner will need to contact CVFPB to comply with Title 23. Dense vegetation on waterward and landward slopes limit visual inspection of potential leaks along pipe alignment. Recommend having owner clear vegetation along slopes.
FIELD_STRUCT_DESC: *ABANDONED* 18-inch corrugated metal gravity drainage pipe through the levee, 13.8 feet below the crown. Slide gate on the waterside (WS) end. [Additional Reference(s): DWR Levee Log, 2005. USACE Sacramento O&M Manual 146, November 1962, (HLM 1.62)].
FS Date: 4/16/2013

WS- slide gate

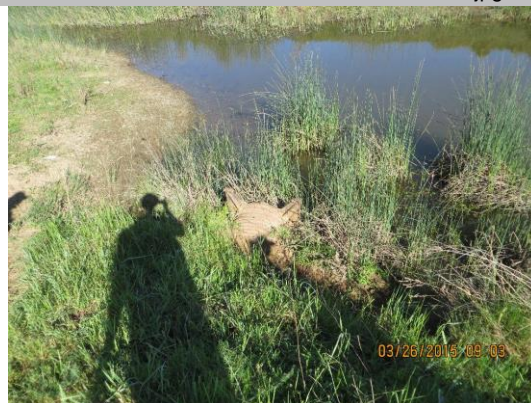
Photo 1 of 3 : UCIP_SP_2018_43946_73422.jpg

LM Start	2.96	Rating **	M	Issue No.	47
LM End	2.96	Issue Type +	Ma	Location *	
Category	Supplemental			GPS Latitude/Longitude	
				Start	End
Item	DWR UCIP LMA Responsibility			39.012552 °	39.012552 °
				-121.466538 °	-121.466538 °
DWR ID					
Comment Code					
Inspector Comment					
FS_ID:43946 DS_ID:18992 EP_NO: N/A Repair Type: Non-Urgent Crossing Status: Found UCIP Comments: Flapgate in closed position, but blocked from operation on WS toe. Pipe appears abandoned and should be verified as having been done so properly. FIELD_STRUCT_DESC: 36-inch corrugated metal gravity drainage pipe through the levee, 13.7 feet below the crown. Slide gate on the waterside (WS) end. Flap gate on the WS end. [Additional Reference(s): DWR Levee Log, 2005. USACE Sacramento O&M Manual 146, November 1962, (HLM 2.97)]. FS Date: 3/26/2015

Pipe and flapgate visible on WS toe.

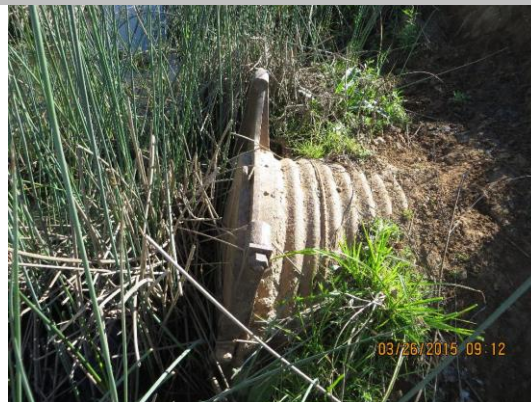
Photo 2 of 3 : UCIP_SP_2018_43946_73421.jpg

Pipe and flapgate visible on WS toe.

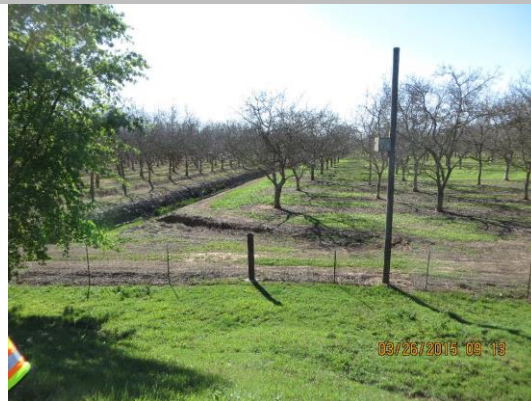
Photo 3 of 3 : UCIP_SP_2018_43946_73420.jpg

LM Start	2.96	Rating **	M	Issue No.	47 (cont)	
LM End	2.96	Issue Type +	Ma	Location *		
Category	Supplemental			GPS Latitude/Longitude		
				Start	End	
Item	DWR UCIP LMA Responsibility			39.012552 °	39.012552 °	
				-121.466538 °	-121.466538 °	
DWR ID						
Comment Code						
Inspector Comment						
FS_ID:43946 DS_ID:18992 EP_NO: N/A Repair Type: Non-Urgent Crossing Status: Found UCIP Comments: Flapgate in closed position, but blocked from operation on WS toe. Pipe appears abandoned and should be verified as having been done so properly. FIELD_STRUCT_DESC: 36-inch corrugated metal gravity drainage pipe through the levee, 13.7 feet below the crown. Slide gate on the waterside (WS) end. Flap gate on the WS end. [Additional Reference(s): DWR Levee Log, 2005. USACE Sacramento O&M Manual 146, November 1962, (HLM 2.97)]. FS Date: 3/26/2015

LS of pipe burried but alignment would place LS outlet just left of telephone pole on LS toe.

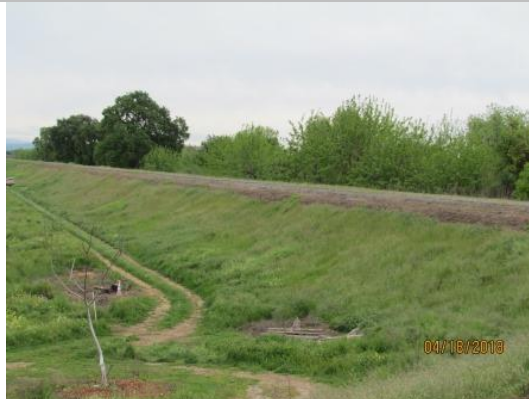
Photo 1 of 1 : SP_2018_RD0817_13_10_20180501_00026.jpg

LM Start	0.00	Rating **	A	Issue No.	10
LM End	3.85	Issue Type +	Ma	Location *	LS
Category	Earthen Levee			GPS Latitude/Longitude	
				Start	End
Item	Vegetation			38.984646 °	38.993339 °
				-121.506111 °	-121.437456 °
DWR ID	DWR_RD0817_02_s_2018_10				
Comment Code					
V1 : Control annual grass and weeds on the levee slopes and easements.					
Inspector Comment					
Annual vegetation is maintained, Spring 2018.

View looking upstream landside of the maintained annual vegetation, Spring 2018.

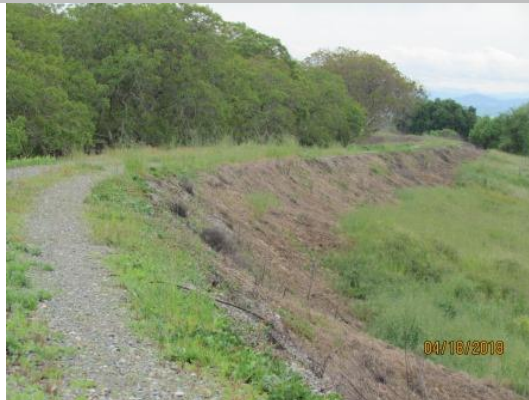
Photo 1 of 1 : SP_2018_RD0817_13_16_20180501_00028.jpg

LM Start	0.00	Rating **	A	Issue No.	16
LM End	3.85	Issue Type +	Ma	Location *	WS
Category	Earthen Levee			GPS Latitude/Longitude	
				Start	End
Item	Vegetation			38.984646 °	38.993339 °
				-121.506111 °	-121.437456 °
DWR ID	DWR_RD0817_02_s_2018_16				
Comment Code					
V1 : Control annual grass and weeds on the levee slopes and easements.					
Inspector Comment					
Annual vegetation is maintained, Spring 2018.

View looking upstream waterside of the maintained annual vegetation, Spring 2018.

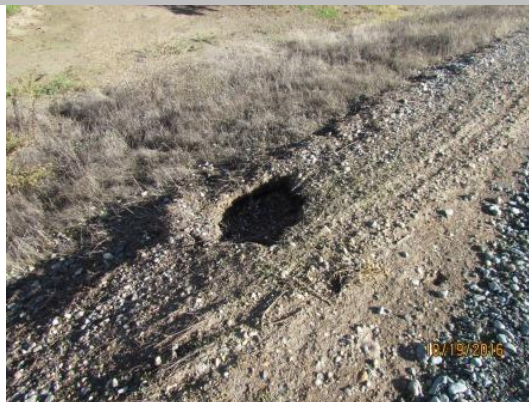
Photo 1 of 1 : SP_2018_RD0817_13_15_20180302_00011.jpg

LM Start	1.47	Rating **	M	Issue No.	15	
LM End	1.47	Issue Type +	Ma	Location *	LS	
Category	Earthen Levee			GPS Latitude/Longitude		
				Start		End
Item	Erosion / Bank Caving			38.986563 °		38.986563 °
				-121.479509 °		-121.479509 °
DWR ID	DWR_RD0817_02_f_2016_15					
Comment Code						
Inspector Comment						
Sink hole were old stump was needs to be backfilled and compacted. Spring 2018.

View of a sink hole were old stump was. This needs to be backfilled and compacted. Fall 2016.

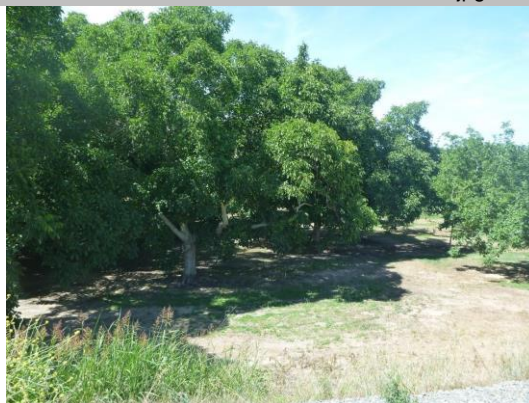
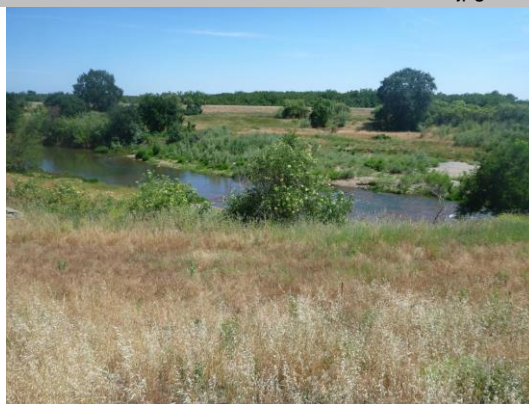
Rating:Area of Concern

Notes: Stability issues are due to levee geometry. Narrow steep slopes.

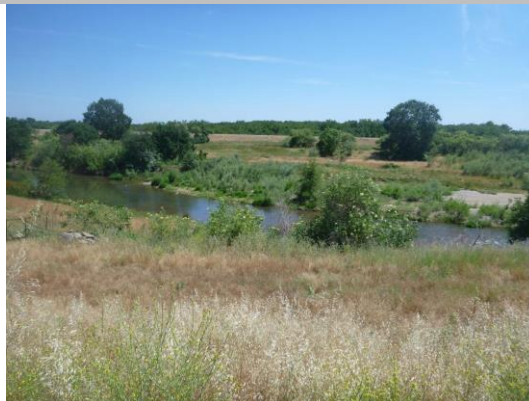
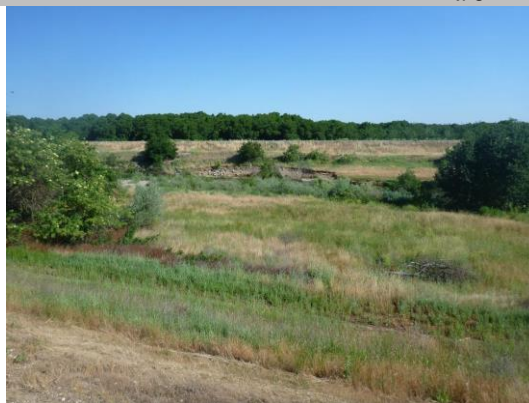
LM Start	2.72	Rating **	A/W	Issue No.	14 (cont)	
LM End	2.74	Issue Type +	Ma	Location *		
Category	Supplemental			GPS Latitude/Longitude		
				Start	End	
Item	2017 Storm Damage			38.992170 °	38.992217 °	
				-121.457332 °	-121.456967 °	
DWR ID	DWR_RD0817_02_f_2017_14					
Comment Code						
Inspector Comment						
Levee Evaluation Comments						
Description:						
Site ID No:161						
Site Designation:240-3						
Repair Type: Erosion						
Rating:Area of Concern						
Field Date:6/5/2017						
Notes: No issue found. Narrow levee with steep slopes. Did not investigate bench due to rattlesnake concerns. Possible alternate location at 38.993282; -121.451562.

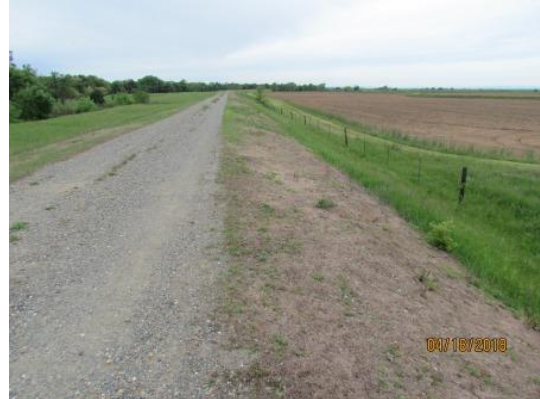
Photo 1 of 1 : SP_2018_RD0817_14_12_20180501_00030.jpg

View looking downstream landside of the maintained annual vegetation, Spring 2018.

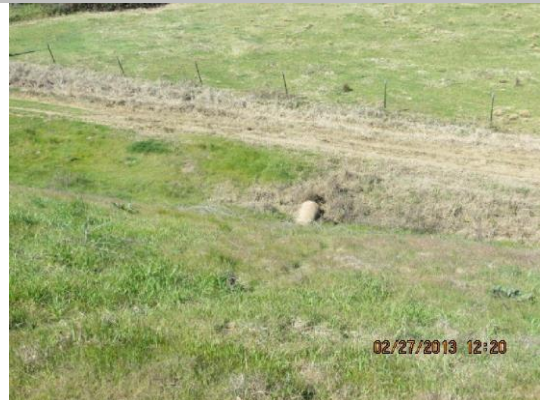
Photo 1 of 3 : UCIP_SP_2018_50231_54271.jpg

Comment Code					
Inspector Comment					
FS_ID:50231 DS_ID:22949 EP_NO: N/A Repair Type: Non-Urgent Crossing Status: Found UCIP Comments: 06/30/2016 Vegetation has been cleared at outlet enough to allow the flapgate to open by half a foot. Recommend rechecking WS outlet prior to flood season to ensure no overgrowth. Dense vegetation at LS but pipe still functional. Crossing has been downgraded from Urgent to Non-Urgent. (K. Fazel - UCIP)02/27/2013 Flap gate partially blocked by vegetation at outlet. (G. Wylie - FPIIB) FIELD_STRUCT_DESC: 18-inch corrugated metal gravity drainage pipe through the levee, 19.5 feet below the crown. Flap gate and headwall on the waterside (WS) end, headwall not found in 2016. (Due to a recent change in the levee alignment, this pipe is no longer in RD0784, Unit 6. Nevertheless, this pipe's original references remain in the RD0784 Levee Log and O&M Manual). [Additional Reference(s): DWR Levee Log, 2005. USACE Sacramento O&M Manual 145.1, August 1955, (Station 21+35), As-Built Drawing No. 2-4-106, Sheet 2, (Station 21+35)]. FS Date: 6/30/2016 9:02:00 AM

Pipe at LS toe

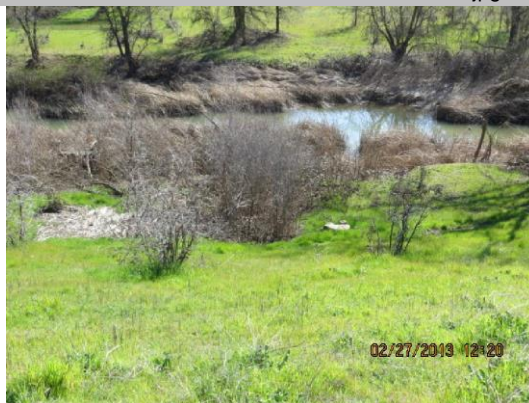
Photo 2 of 3 : UCIP_SP_2018_50231_54270.jpg

FS_ID:50231
DS_ID:22949
EP_NO: N/A
Repair Type: Non-Urgent
Crossing Status: Found
UCIP Comments: 06/30/2016 Vegetation has been cleared at outlet enough to allow the flapgate to open by half a foot. Recommend rechecking WS outlet prior to flood season to ensure no overgrowth. Dense vegetation at LS but pipe still functional. Crossing has been downgraded from Urgent to Non-Urgent. (K. Fazel - UCIP)02/27/2013 Flap gate partially blocked by vegetation at outlet. (G. Wylie - FPIIB) FIELD_STRUCT_DESC: 18-inch corrugated metal gravity drainage pipe through the levee, 19.5 feet below the crown. Flap gate and headwall on the waterside (WS) end, headwall not found in 2016. (Due to a recent change in the levee alignment, this pipe is no longer in RD0784, Unit 6. Nevertheless, this pipe's original references remain in the RD0784 Levee Log and O&M Manual). [Additional Reference(s): DWR Levee Log, 2005. USACE Sacramento O&M Manual 145.1, August 1955, (Station 21+35), As-Built Drawing No. 2-4-106, Sheet 2, (Station 21+35)].

Outlet in brush at WS toe.

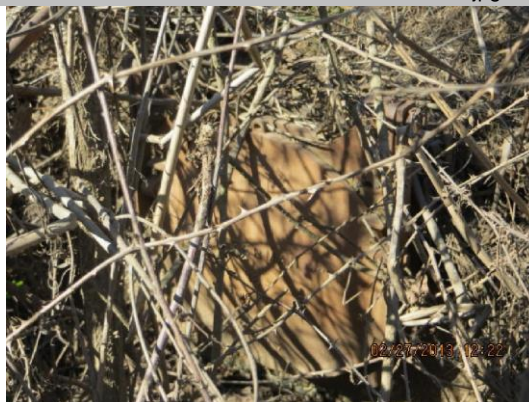
Photo 3 of 3 : UCIP_SP_2018_50231_54269.jpg

Flap gate blocked by vegetation on WS toe.

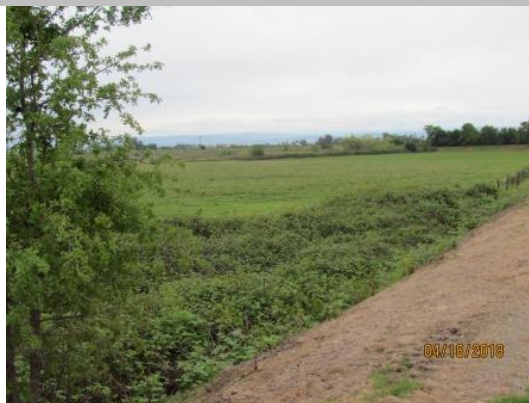
Photo 1 of 1 : SP_2018_RD0817_14_8_20180501_00031.jpg

View of blackberry bushes that are taking over the landside slope looking upstream. Spring 2018.

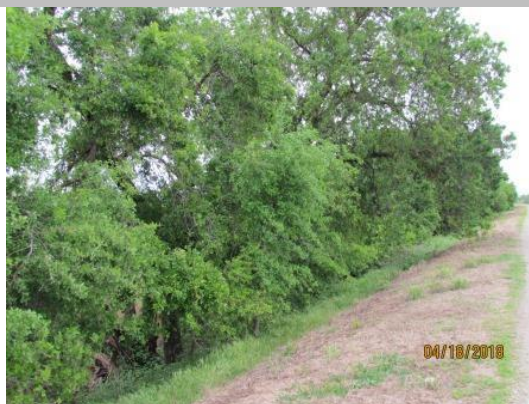
Photo 1 of 2 : SP_2018_RD0817_14_4_20180501_00032.jpg

LM Start	0.53	Rating **	M	Issue No.	4
LM End	0.63	Issue Type +	Ma	Location *	LS
Category	Earthen Levee			GPS Latitude/Longitude	
				Start	End
Item	Trim / Thin Trees			38.989855 °	38.990621 °
				-121.502229 °	-121.500676 °
DWR ID	DWR_RD0817_03_s_2015_4				
Comment Code					
T1 : Trim trees to at least five feet above ground level.					
Inspector Comment					
Trim tree limbs for access and visibility. Spring 2018.

View looking downstream of trees that need limbs to be trimmed for access and visibility, Spring 2018.

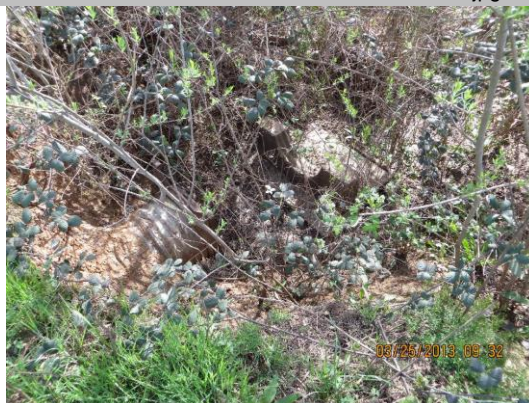
Photo 3 of 3 : UCIP_SP_2018_50230_53847.jpg

Comment Code						
Inspector Comment						
FS_ID:50230 DS_ID:22950 EP_NO: N/A Repair Type: Urgent Crossing Status: Found UCIP Comments: 06/30/2016 Holes still present through pipe on corroded landside (LS) end. Pipe still half full of debris as visible thru LS end. Good candidate for removal via DWR's Deferred Maintenance Program. WS vegetation cleared in the immediate vicinity of flapgate. Potential for overgrowth at WS end nevertheless imminent. Note that this pipe does not cause LS nuisance flooding per Tom Engler of MBK. (K. Fazel - UCIP)03/25/2013 Pipe heavily corroded and failing at inlet an outlet. (G. Wylie - FPIIB) FIELD_STRUCT_DESC: 24-inch corrugated metal gravity drainage pipe through the levee, 20.5 feet below the crown. Flap gate and headwall on the waterside (WS) end. (Due to a recent change in the levee alignment, this pipe is no longer in RD0784, Unit 6. Nevertheless, this pipe's original references remain in the RD0784 Levee Log and O&M Manual). [Additional Reference(s): DWR Levee Log, 2005. USACE Sacramento O&M Manual 145.1, August 1955, (Station 35+57), As-Built Drawing No. 2-4-106, Sheet 4, (Station 35+57)]. FS Date: 6/30/2016 9:02:00 AM

Pipe no longer mounted to headwall at WS toe.

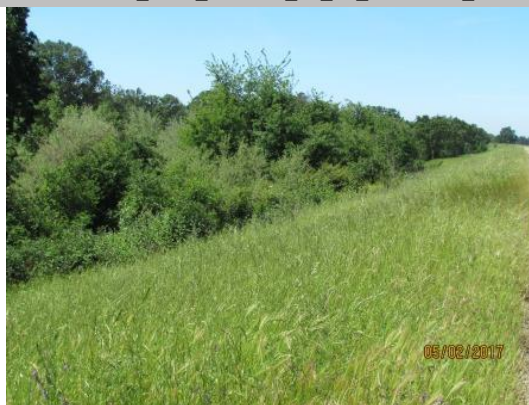
Photo 1 of 1 : SP_2018_RD0817_14_20_20180302_00007.jpg

LM Start	0.55	Rating **	M	Issue No.	20
LM End	0.60	Issue Type +	Ma	Location *	WS
Category	Earthen Levee			GPS Latitude/Longitude	
				Start	End
Item	Vegetation			38.989976 °	38.990403 °
				-121.501970 °	-121.501110 °
DWR ID	DWR_RD0817_03_s_2017_20				
Comment Code					
V2 : Remove the wild growth other than native grasses from the levee slopes.					
Inspector Comment					
Trees and dense bushes need to be remove from levee slope.

View looking downstream of trees and bushes that block the view of the levee slope, Spring 2017 and remain the same for Fall 2017.

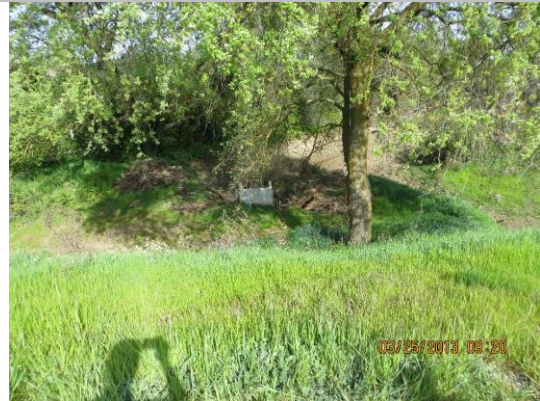
Photo 3 of 3 : UCIP_SP_2018_50232_53852.jpg

Comment Code						
Inspector Comment						
FS_ID:50232 DS_ID:22951 EP_NO: N/A Repair Type: Urgent Crossing Status: Found UCIP Comments: 06/30/2016 Corrosion still present on WS end. Inlet box was replaced 5 years ago and appears to be functioning properly due to the presence of a screen that prevents debris blockage. Flap gate functions properly only sometimes. WS heavily vegetated. (K. Fazel - UCIP) 03/25/2013 Corrosion holes on WS toe and flap gate is blocked by debris. Flap gate broken. Inlet partially blocked at concrete inlet. (G. Wylie - FPIIB) FIELD_STRUCT_DESC: 24-inch corrugated metal gravity drainage pipe through the levee, 20 feet below the crown. Flap gate and headwall on the waterside (WS) end. 56-inch by 34-inch concrete inlet box on the landside (LS) toe. (Due to a recent change in the levee alignment, this pipe is no longer in RD0784, Unit 6. Nevertheless, this pipe's original references remain in the RD0784 Levee Log and O&M Manual). [Additional Reference(s): DWR Levee Log, 2005. USACE Sacramento O&M Manual 145.1, August 1955, (Station 43+17), As-Built Drawing No. 2-4-106, Sheet 4, (Station 43+17)]. FS Date: 6/30/2016 9:03:00 AM

Improvised concrete inlet on LS toe.

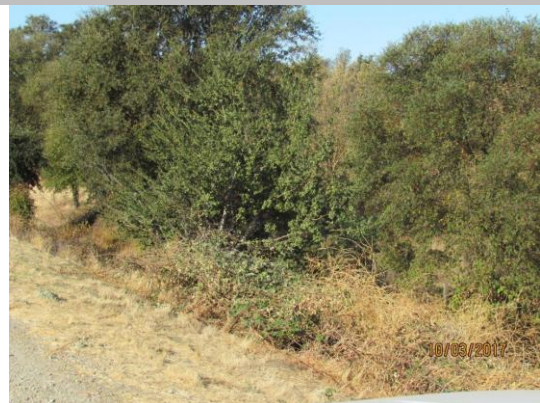
Photo 1 of 1 : SP_2018_RD0817_14_19_20180302_00006.jpg

LM Start	0.77	Rating **	M	Issue No.	19
LM End	0.77	Issue Type +	Ma	Location *	LS
Category	Earthen Levee			GPS Latitude/Longitude	
				Start	End
Item	Trim / Thin Trees			38.991879 °	38.991879 °
				-121.498688 °	-121.498688 °
DWR ID	DWR_RD0817_03_f_2016_19				
Comment Code					
T1 : Trim trees to at least five feet above ground level.					
Inspector Comment					
Trim tree limbs for access and visibility. Spring 2018.

View looking downstream landside of trees that need limbs to be trimmed for access and visibility, Fall 2017.

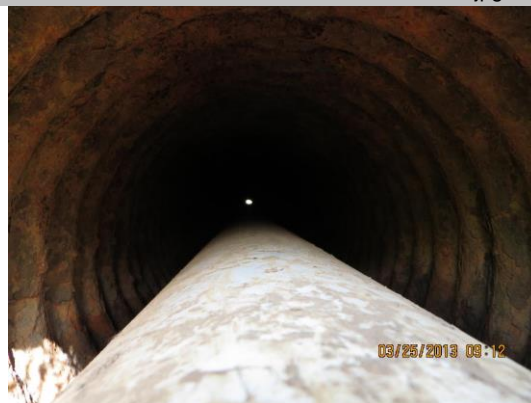
Photo 3 of 3 : UCIP_SP_2018_50234_53855.jpg

FS_ID:50234
DS_ID:22952
EP_NO: N/A
Repair Type: Urgent
Crossing Status: Found
UCIP Comments: 06/30/2016 Same as last inspection. Good candidate for removal via DWR's Deferred Maintenance Program. Pipe used to drain pastureland which have since been converted to rice fields that drain on opposite side of fields, rendering the drainage function of this pipe obsolete. This pipe is not needed and causes nuisance flooding at high water on landside (LS) per Tom Engler of MBK. As such, operation of flapgate is still blocked via a post at WS end. Pipe is sleeved but sleeve has grossly deteriorated. LS end of pipe appears bent. (K. Fazel - UCIP)03/25/2013 Pipe heavily corroded and damaged. 8-inch PVC pipe runs through pipe/possibly for irrigation. CMP heavily rusted on WS toe and debris blocking flap gate on WS toe. (G. Wylie - FPIIB) FIELD_STRUCT_DESC: *ABANDONED* 20-inch corrugated metal gravity drainage pipe through the levee, 16.5 feet below the crown. 8-inch polyvinyl chloride (PVC) pipe sleeved through the 20-inch corrugated metal pipe with the annular space left void. Flap gate on the waterside (WS) end. (Due to a recent change in the levee alignment, this pipe is no longer in RD0784, Unit 6. Nevertheless, this pipe's original references remain in the RD0784 Levee Log and O&M Manual). [Additional Reference(s): DWR Levee Log, 2005, 24-inch corrugated metal pipe (CMP) referenced. USACE Sacramento O&M Manual 145.1, August 1955, (Station 69+17), 18-inch CMP referenced, As-Built Drawing No. 2-4-106, Sheet 4, (Station 69+17)].

Pipe heavily corroded throughout.

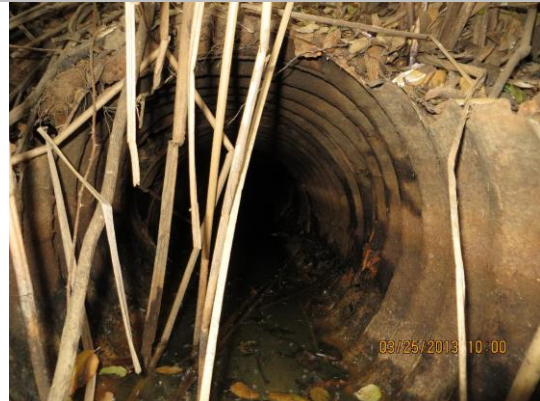
Photo 1 of 3 : UCIP_SP_2018_50235_53859.jpg

FS_ID:50235
DS_ID:22953
EP_NO: N/A
Repair Type: Urgent
Crossing Status: Found
UCIP Comments: 06/30/2016 Sink hole still exists over pipe on LS. LS and WS heavily vegetated and barely accessible. WS end is sleeved with a heavily rusted CMP. Flapgate is clear and functional. (K. Fazel - UCIP)12/17/2015 WS accessible, but LS no longer accessible due to heavy vegetation. (T. Hatch - UCIP)03/25/2013 Pipe visible on LS at toe of roadway embankment, but not visible on WS. Possible sinkhole over pipe at LS toe. Pipe heavily rusted. (G. Wylie - FPIIB)
FIELD_STRUCT_DESC: 18-inch corrugated metal gravity drainage pipe angled through the levee, approximately 15 feet below the crown. Steel pipe sleeved through the 18-inch corrugated metal pipe (CMP) with annular space grouted, grout only on the waterside (WS). Flap gate on the WS end. Pipe alignment is from the west of the intersection of Forty Mile Road and 45 degrees to the WS. Outlet is on the eastern side of Forty Mile Road, looking upstream. (Due to a recent change in the levee alignment, this pipe is no longer in RD0784, Unit 6. Nevertheless, this pipe's original references remain in the RD0784 Levee Log and O&M Manual). [Additional Reference(s): DWR Levee Log, 2005. USACE Sacramento O&M Manual 145.1, August 1955, (Station 74+72), As-Built Drawing No. 2-4-106, Sheet 4, (Station 74+72)].

Pipe at inlet on LS toe.

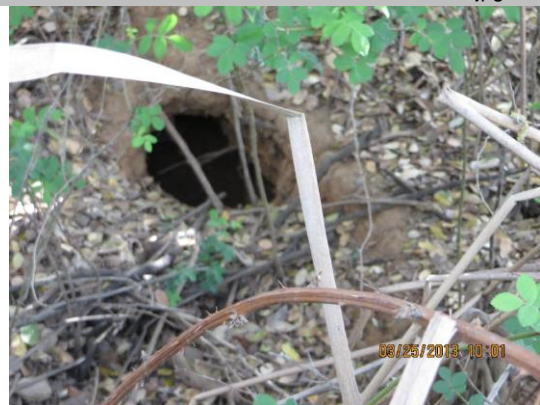
Photo 2 of 3 : UCIP_SP_2018_50235_53858.jpg

Sinkhole or animal burrow over pipe on LS toe.
